2018/19

Refit of 14 Meter sailing yacht

1969 round bilge steel ketch. Built in La Spezia Italy.

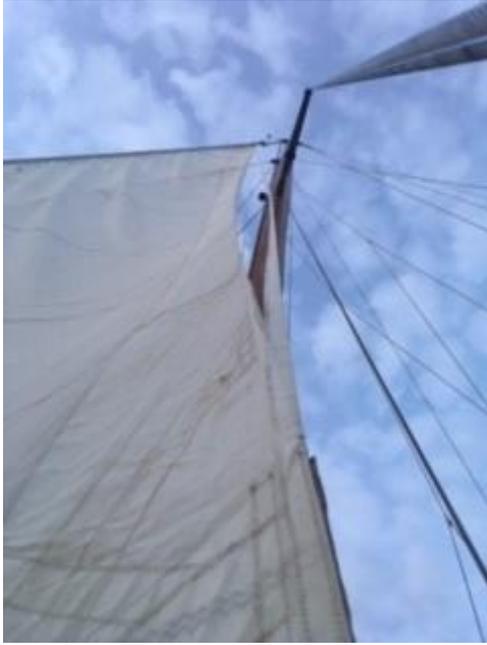
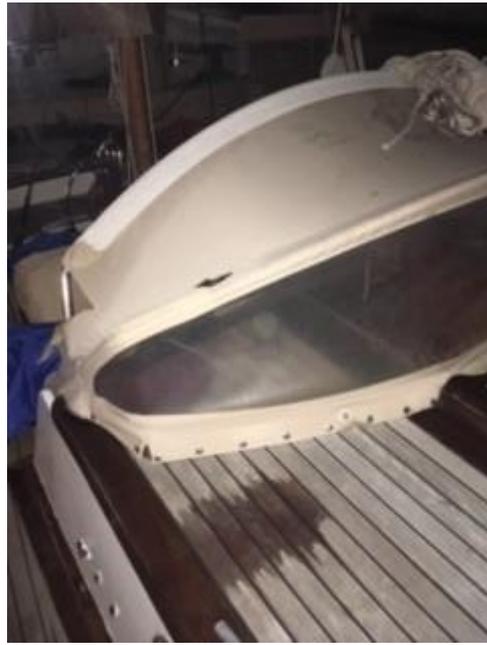
We departed Elba on the 2nd November for a shakedown sail. The passage to Viareggio was exciting to say the least. We departed with a 10 to 15 knot Easterly wind forecast. We sailed through the night and sustained 30 knots wind off Livorno in the middle of the night. We had a few issues. The engine stopped, the Genoa sail tore along the luff due to there not being a UV cover on the roller furler. Also there was a substantial leak through the main mast gasket.

The sails were immediately sent to the same sailmaker who fabricated them. The spray dodger was also sent off for a new one to be made.

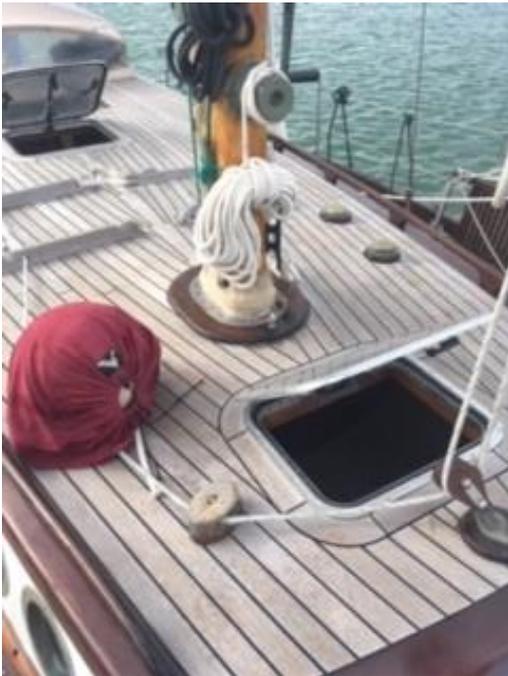
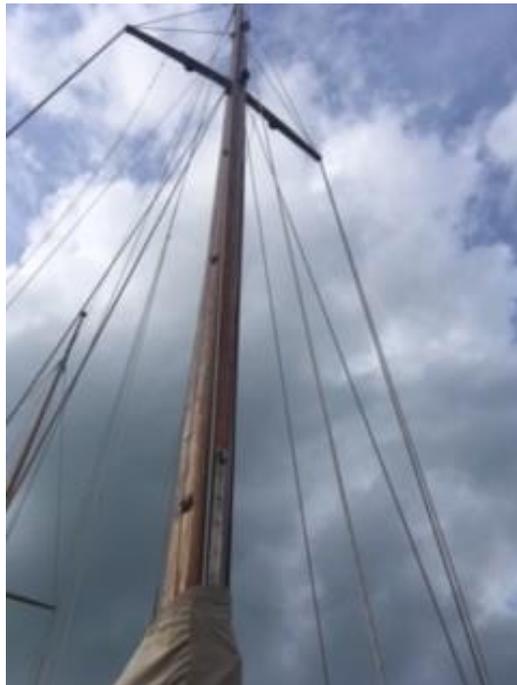
The mast was leaking due to the teak ring around the mast being cracked and rotten. The plan is to remove the masts and revise the rigging and varnish, so a new teak seal will be installed when re-stepping the mast.

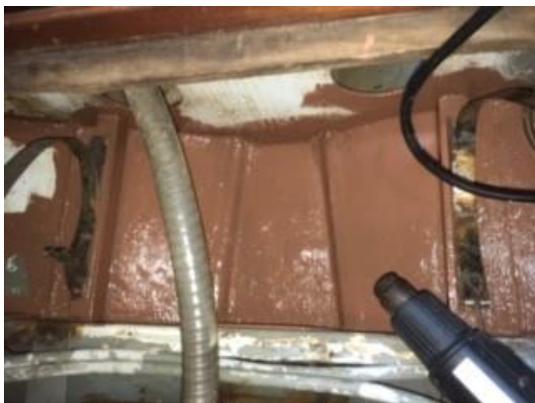
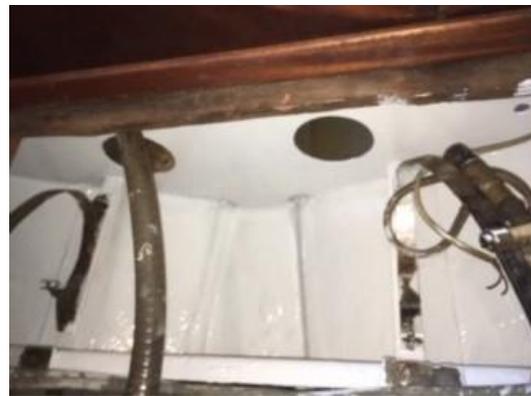
The Bilges are really surprisingly good . After 8 years since the refit, there is no ongoing corrosion. The pitting from the sandblasting is apparent but there is no ongoing active rust.

I used the time before the drydock was ready to start on the bilge treatment. We are treating bilges at work on Rahil and I have the luxury of a supply of the best available paint on the market. Corroless. The pink or brown EPF anti corrosive primer was developed for the offshore North Sea oilfields. It sets like ceramic coat and is really a one time only application

The bilges were sanded and ground where necessary and the 2 coats of the Corroless EPF primer and 2 coats of Corroless white. Bilge paint is my priority. Once boat out of the water the rest of the bilges and tanks will be also completed. So we are starting on a good footing.

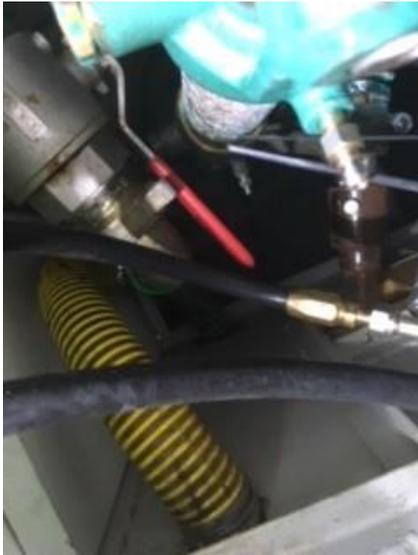
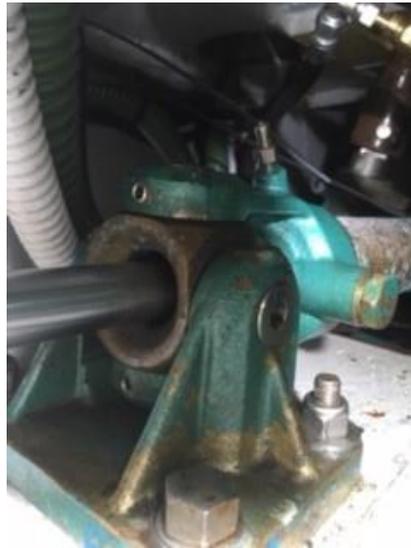
The steering equipment is hydraulic. It is very high quality and I was very impressed. It is a little difficult to access from the lazarette. But doable. I will eventually get in here and repaint this area but the bilge paint is good and the steering gear very substantial. It will need to be greased and cleaned but it is great to know.

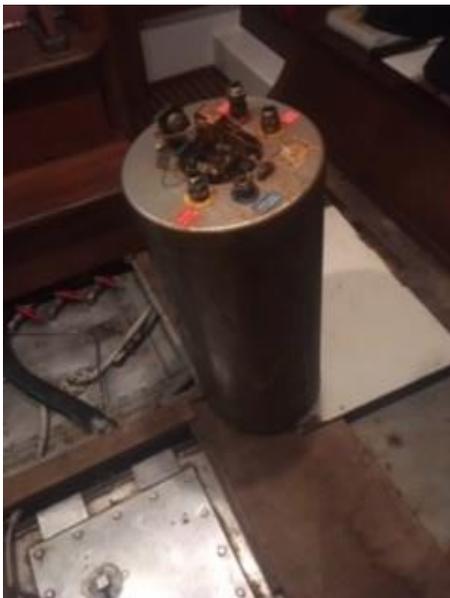
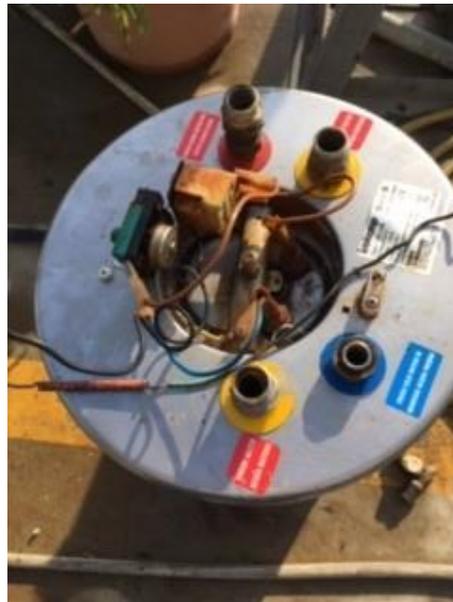
The hot water boiler was not working. So I extracted it and overhauled it. The body was stainless steel and in good condition. I replaced element, Thermostat and electric microswitch. De calcified it and polished it up.

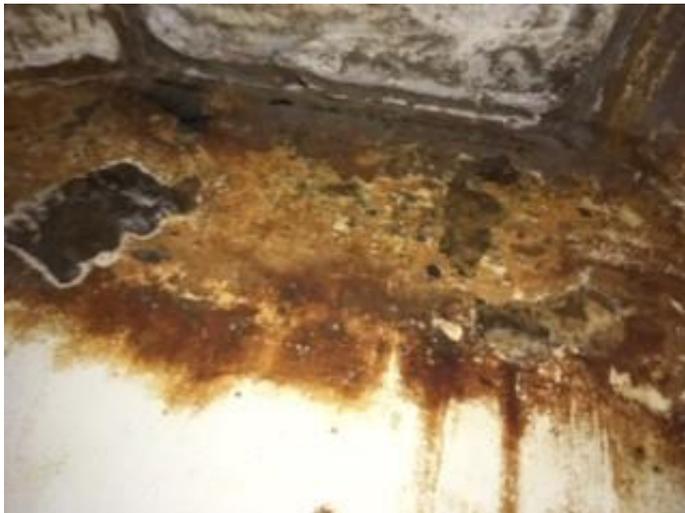
In the right of this picture you can see a black blotch. This was the only piece of rust in the actual keel and I attacked it with the grinder and rattle gun and it was not deep. The corroless paint system will be used in the bilges to stabilize them for the future.

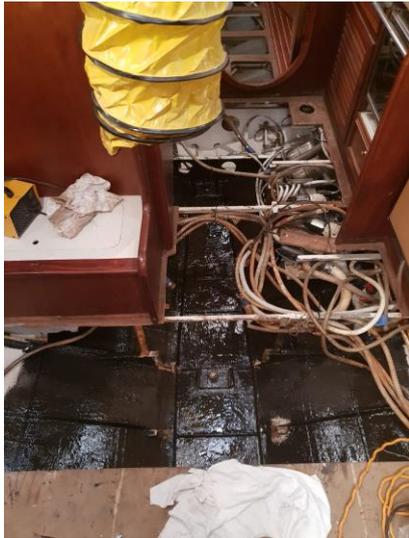
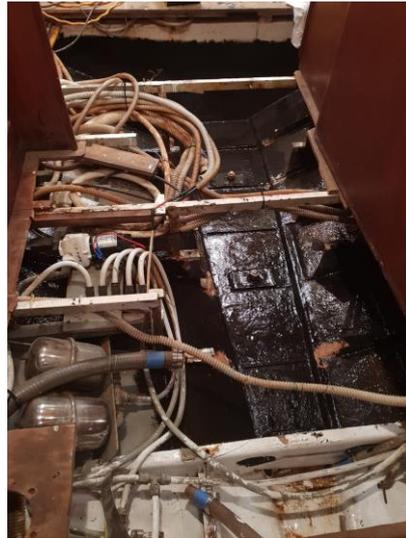
This picture is of the main bilge bulkhead joining the fuel tank. It was my greatest concern and the principle reason why I wanted to address these bilges. Because I could see some rust blisters against the wall of the tank. If there were to be a hole rust through it will be the worst scenario. With fuel in the bilge.

Anyway, the rust was there but it is not deep. It is superficial.

Bilges coated in Black EPF corroless primer. The second coat was pink in colour which is good to make sure that you are covering 100%

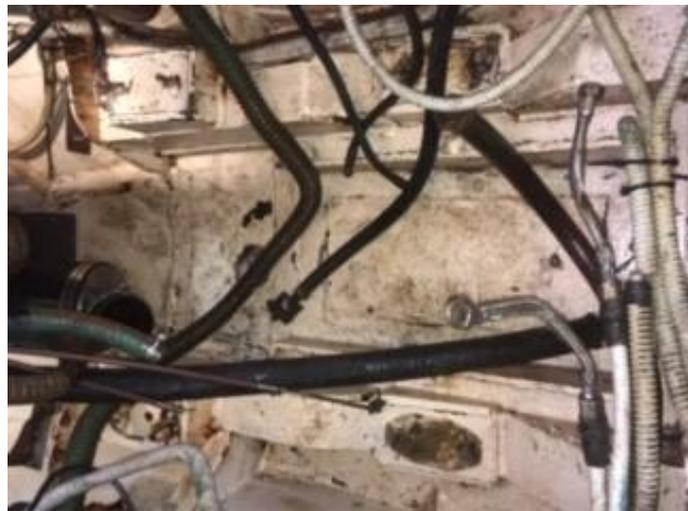
Once I cleaned out 10 CM of mud and oil from the engineroom bilges. I discovered the bilge paint to be almost perfect. Protected by the oil and sludge, there was no corrosion at all.

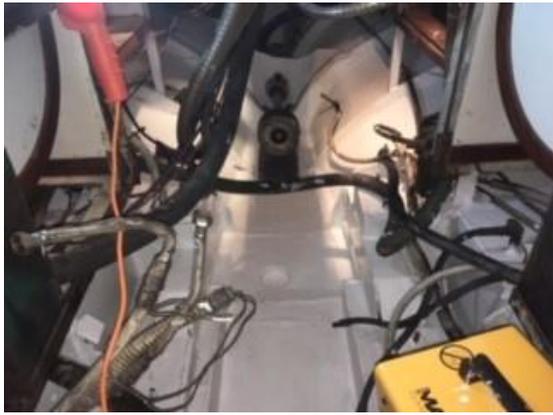
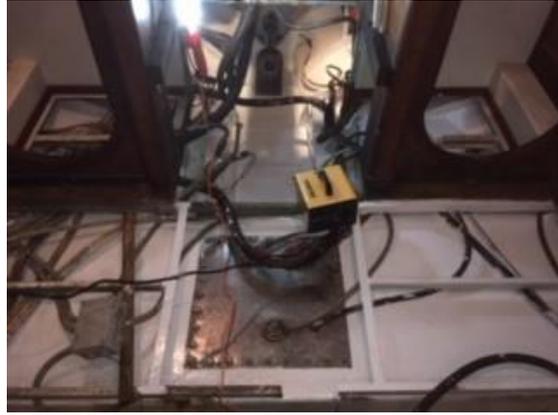
But I got in there and treated any corrosion with Corroless EPF and 2 coats of Corroless white bilge paint anyway. Including the fuel tank tops. There were a couple of rust spots on the tank top. Nothing serious but the tank tops are properly treated and painted now.

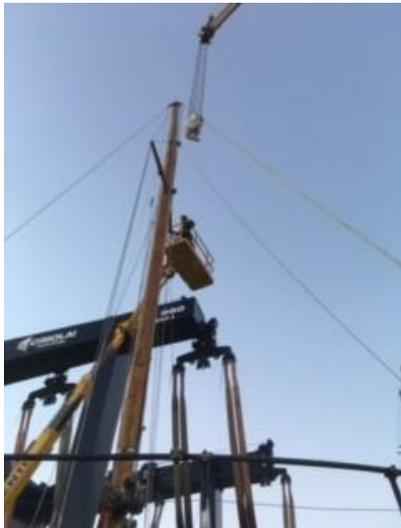
Mizzen took a long time to remove. The timber had swollen and it took a lot of manipulation to remove it.

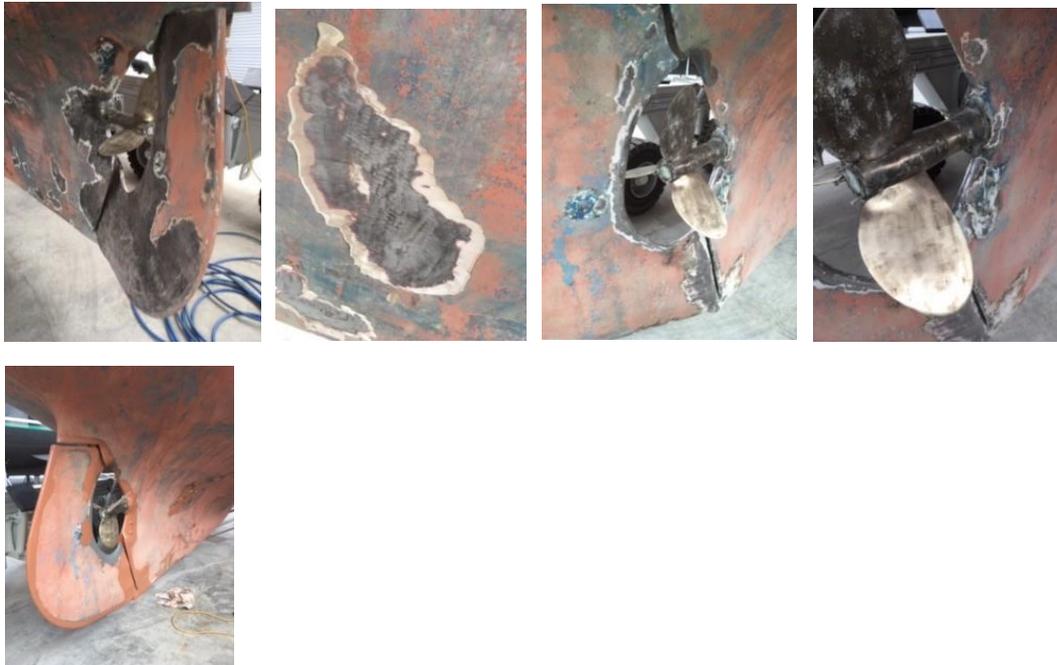
I started works on the steel hull. There was not a lot of corrosion on the outside. There was quit a lot of flaking paint around the rudders which I feathered out. We are using the Corroless primer as metal primer on all areas.

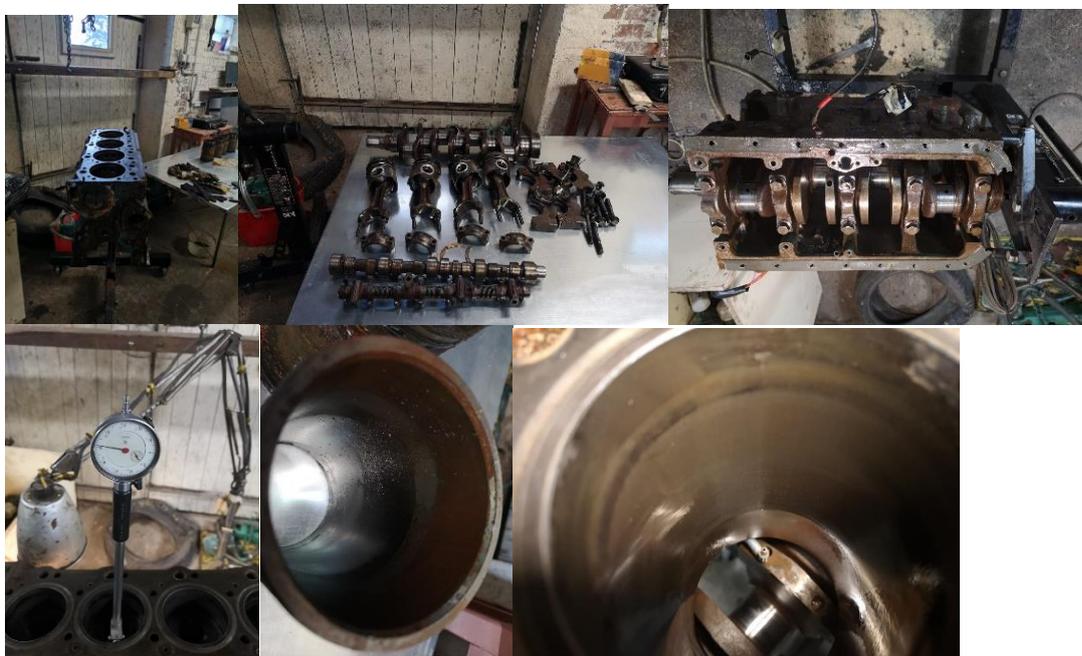
The news on the engine was good. The crank and big end bearings were sent to check and the tolerances are perfect. As specified in the manual. So the expensive parts are good.

The bad news was that 2 of 4-cylinder liners were in need of replacement. He measured them for roundness and 2 liners were over the tolerance for roundness. The liners can only be ordered as a set including piston and conrod. So we will reorder 4 complete sets. That means we will have some spare pistons and conrods once the engine is rebuilt. Algis's father will make a full rebuild report on the refurbishment in any case. But there is nothing major wrong with the engine. All parts will be replaced. The rocker arm and overhead assembly all OK. Fuel pump OK water pumps OK. We will replace 2 valves. The engine will be sandblasted, and powder coated.

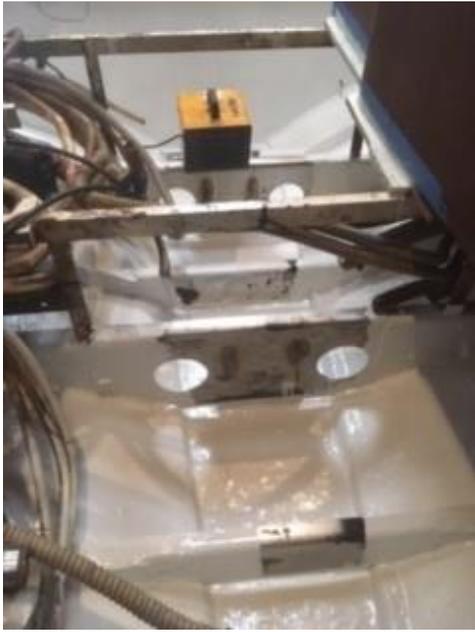
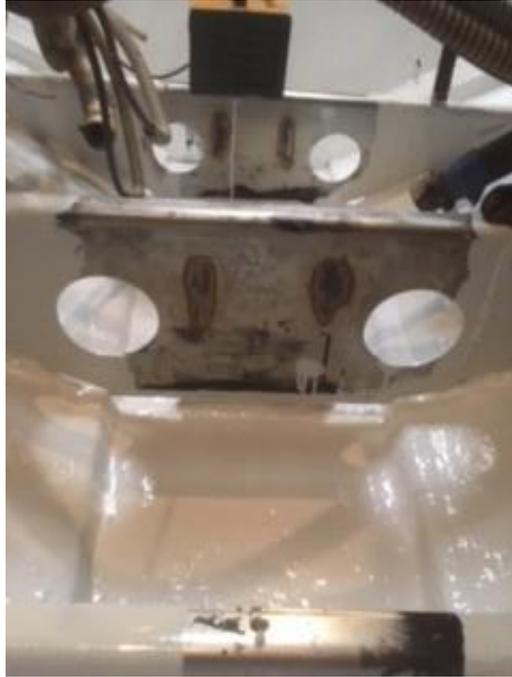
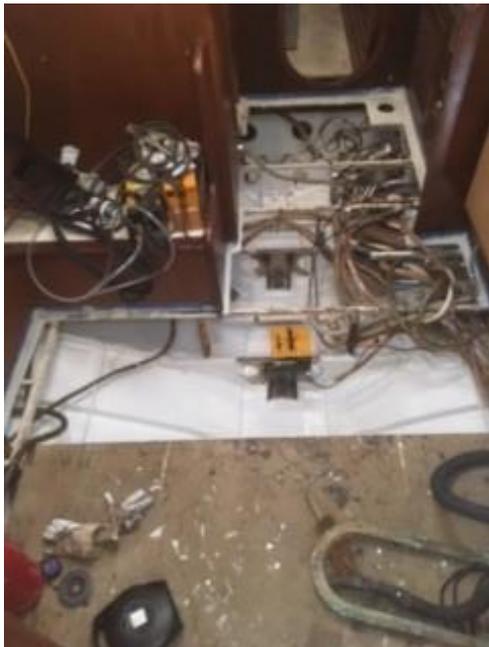
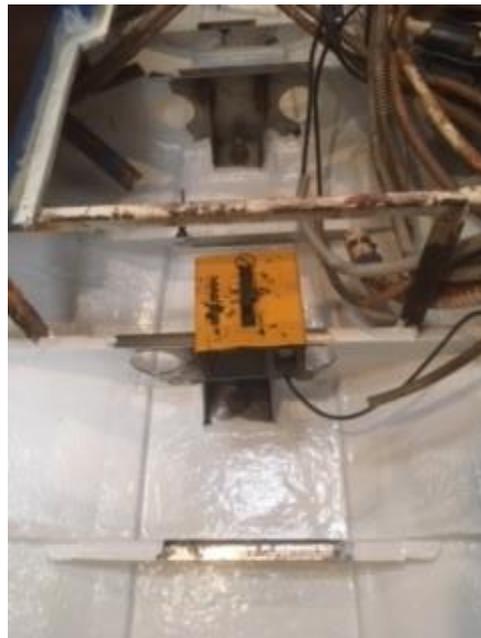
I decided to remove the old bilge frames and replace with stainless steel while I had the tanks out. I don't want to worry about it again. The corrolless paint is good but invariably corrosion returns. So we replaced 5 bilge floors for stainless steel.

These bilges are 100% sorted now. With the stainless steel floors welded in and the bilges were completely treated with rattlegun, sandblasted and 3 coats of Corroless primer and 3 coats of Corroless bilge paint applied. Also, The aft end of the bilge adjoins the fuel tank, so this partition was treated with Belzone. (Plastic metal). To prevent any risk of corrosion on the fuel tank partition.

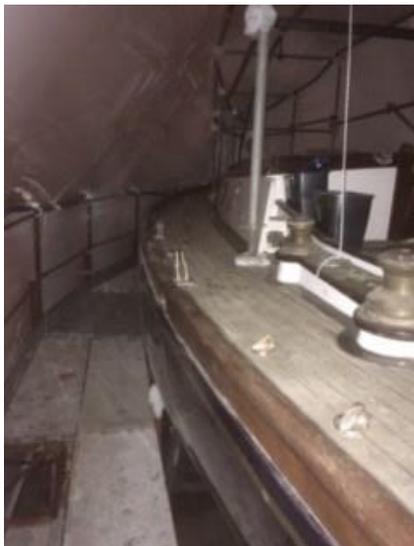
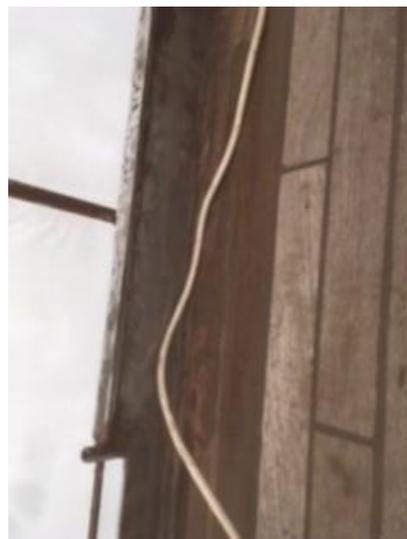
I just smashed it. With a chisel and hammer, I removed the margine plank and left plywood underneath as it was in perfect condition.

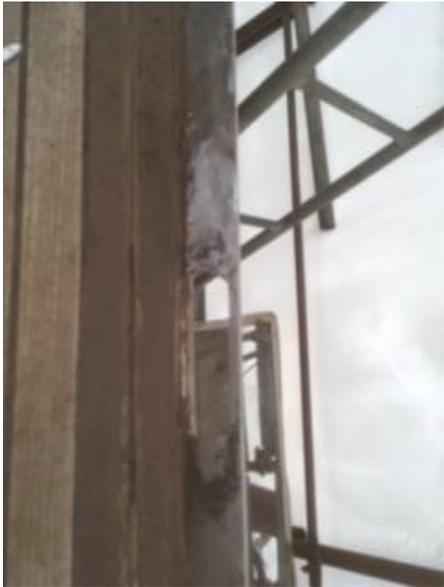
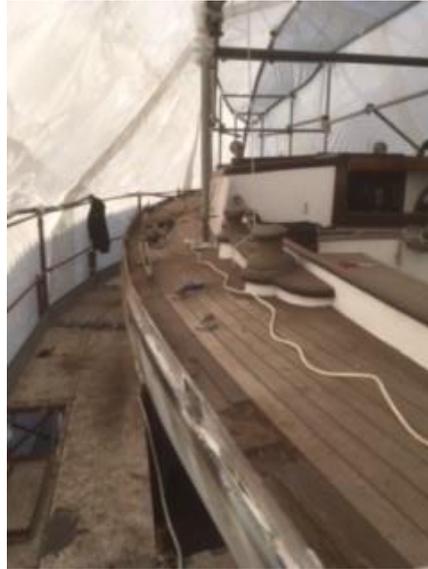
The teak on the inner and outer side of the capping rail came off and the corrosion was treated properly with sandblasting and corroleless paint.

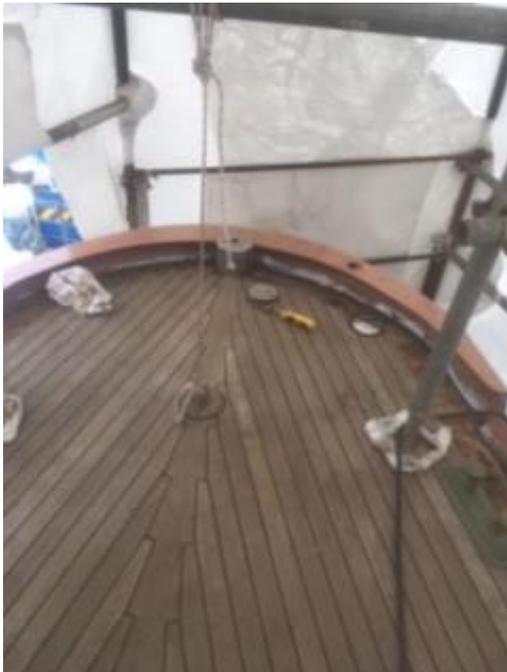
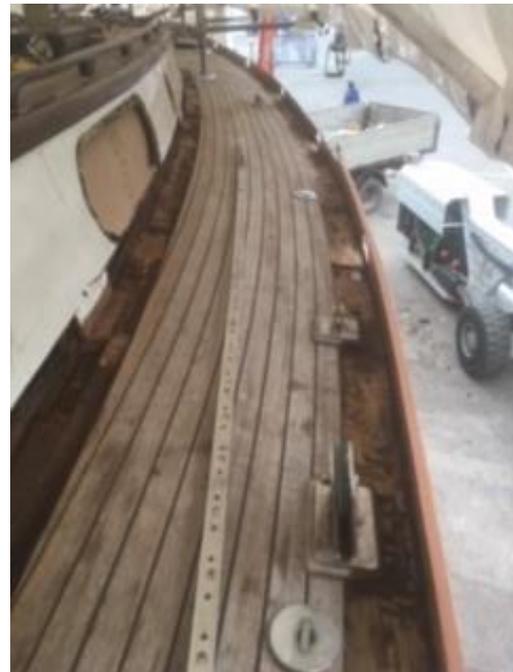
Old hahogany margine plank chizelled out to conserve the plywood underneath.

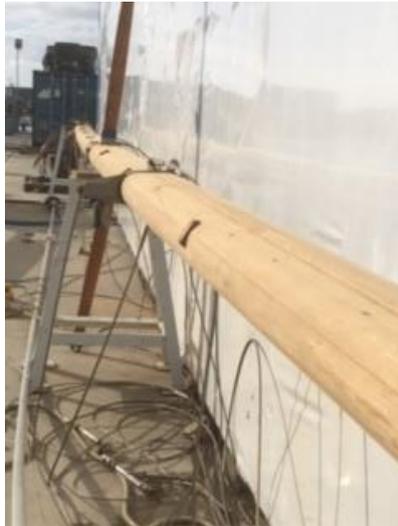
The Mizzen mast had an area of dry rot in it so I had a specialist remove it and scarf in a new section. Both masts were given a teak shoe to prevent moisture rising from underneath.

The masts were stripped bare and sanded clean. They were coated with 3 coats of Epifanes PP diluted 50% for first absorption. A total of 20 Coats of PP was applied including the initial 3 coats. The masts were turned over after every 6 coats and sanded flat to enable grain filling. Finally they were coated with 3 coats of Epifanes natural varnish.

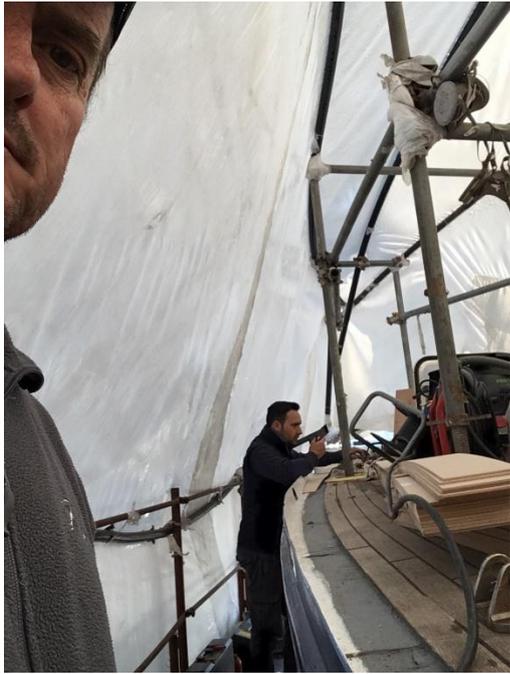
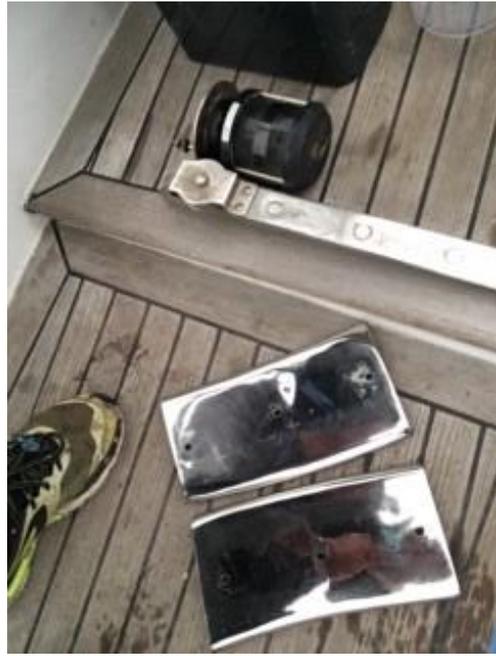
Margine-planks removed. Rusting toerails and scuppers treated with Corroless paint and inside with Awlgrip off white.

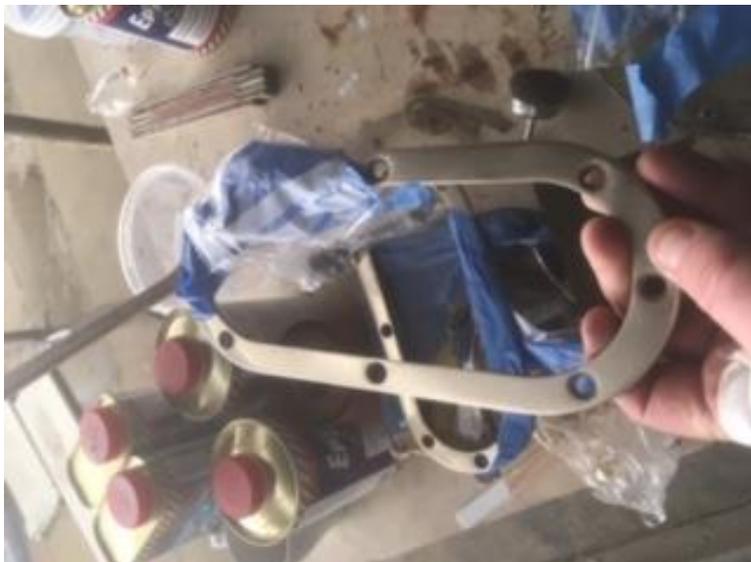
With the sandblasting and 3 coats of corroless primer and 2 coats of Awlgrip 545 primer. These toe rails will hopefully never rust again.

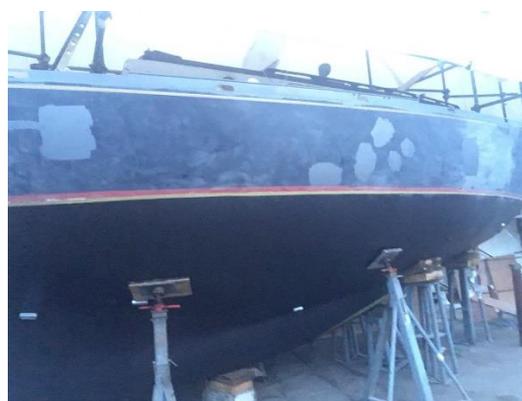
The underwater area was completed. There were areas of rust blisters. Not large ones but small coin size ones. They were treated with rattlegun and grinder. 2 coats of Corroless anti rust primer applied followed by international epoxy filler. The whole hull was sanded and re-faired with this filler. Then the whole boat was primed with an international bridging primer coat 2 coats. 3 coats of Hempel black antifoul applied and then new anodes.

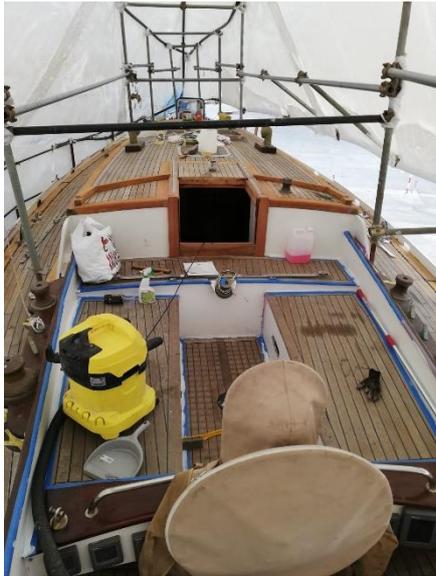
There was some wood rot in the cabin sides along the deck. It was due to a mahogany fillet rail which was installed and it kept water and caused the mahogany cabin sides to swell. We removed the bottom 5 inches and replaced with a 5 inch strip.

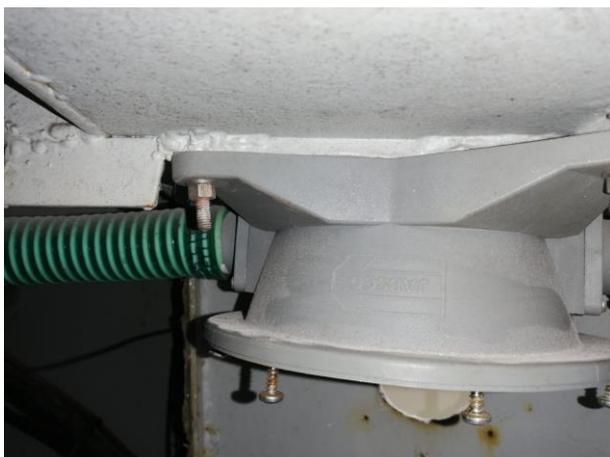
I removed this hand bilge pump in the cockpit and ordered a rebuild kit. This will be something Rina will want to see working. The rubber membrane was completely gone.

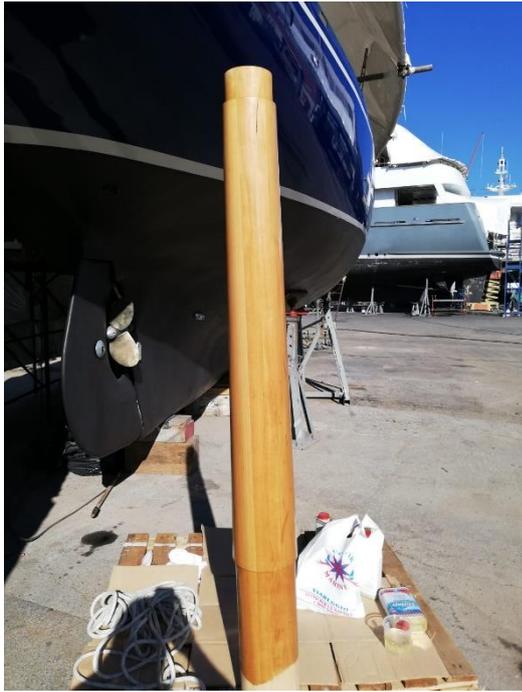
New bowsprit arrived. I decided to ask to make a new one. The old one was cracked and had water inside for who knows how long? The new one is a work of art. We immediately coated with 6 coats of Epifanes PP and sealed it.

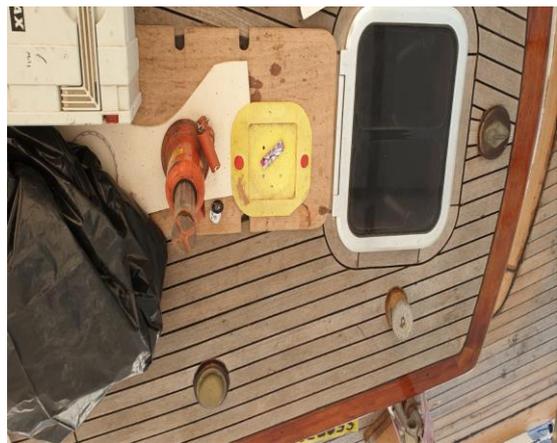
We cut out the cabin top caulking because the old rubber was brittle and the cabin top had some leaks. The deck is in good order because it was covered with an epoxy membrane before laying the teak. So We just re caulked.
