2018/19

Refit of 14 Meter sailing yacht

1969 round bilge steel ketch. Built in La Spezia Italy.

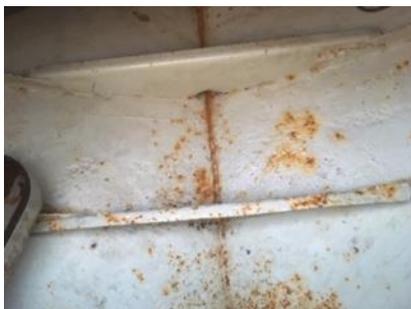
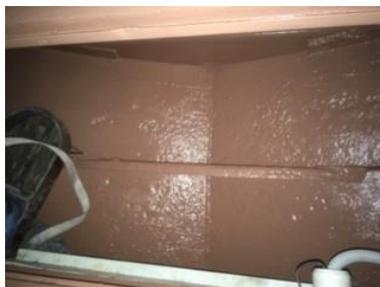
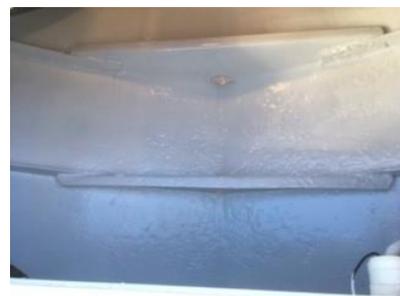
The Bilges are really surprisingly good . After 8 years since the refit, there is no ongoing corrosion. The pitting from the sandblasting is apparent but there is no ongoing active rust.

The bilges were sanded and ground where necessary and the 2 coats of the Corroless EPF primer and 2 coats of Corroless white. Bilge paint is my priority. Once boat out of the water the rest of the bilges and tanks will be also completed. So we are starting on a good footing.

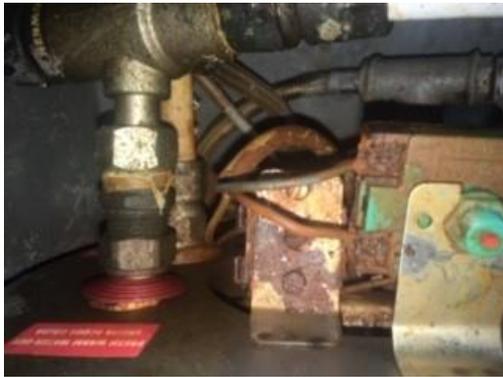
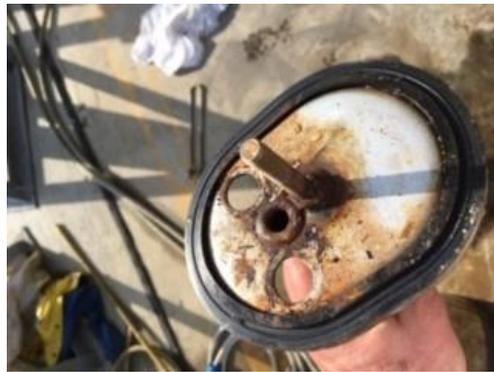
The hot water boiler was not working. So I extracted it and overhauled it. The body was stainless steel and in good condition. I replaced element, Thermostat and electric microswitch. De calcified it and polished it up.

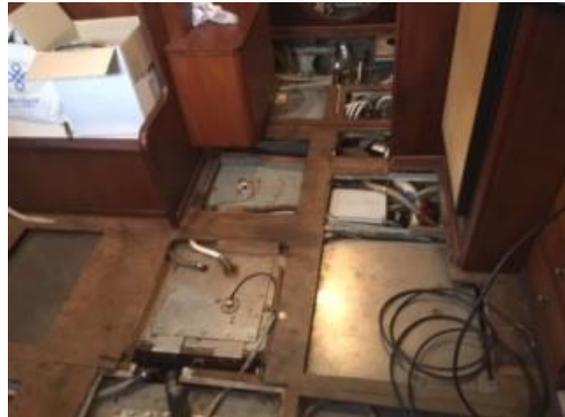
In this picture you can see the 3 tanks. Closest (full beam is the water tank.)

In the middle is the black water tank and the far one is the grey water tank.

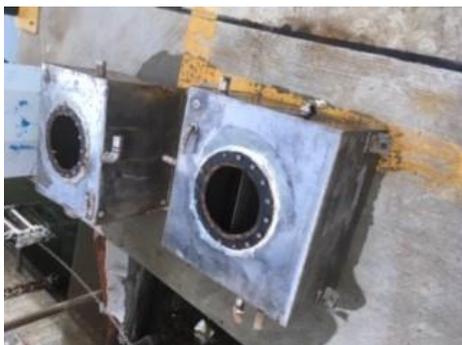
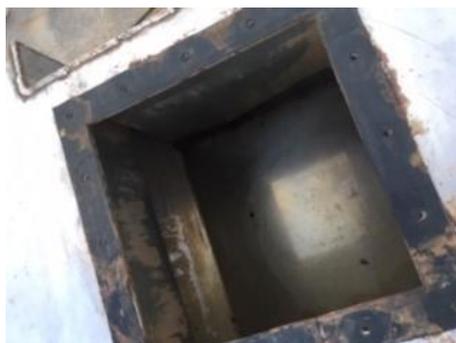
The next morning I cleaned them up and had a good look at them. I filled them with water and found one of them had a leak.

I realized that the fresh water tank and the Black water tank were leaking and I sent them off to be welded up. But they were too bad so I ordered new ones to be made. . The grey tank had been beaten up badly. Was probably not replaced at refit. Lots of dents in it and there was a small leak. So I decided to replace them for new ones

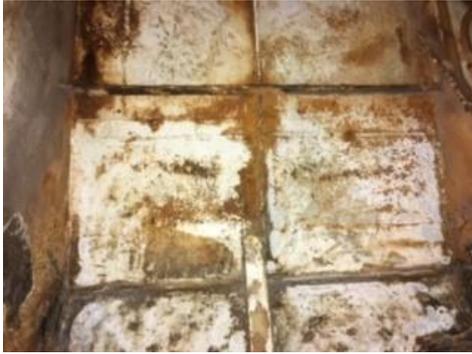
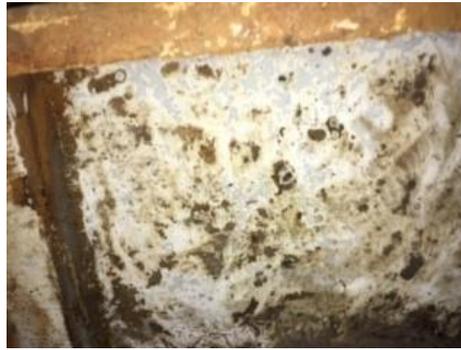
The bilges were not bad at all. In these pictures you can see where I sanded off the dirt and oil with a sander and the paint is mostly intact. There is a bit of corrosion on the steel brackets that were holding the stainless-steel tanks but I will change these frames for Stainless steel ones.

I decided to remove the old bilge frames and replace with stainless steel while I had the tanks out. I don't want to worry about it again. The corrolless paint is good but invariably corrosion returns. So we replaced 5 bilge floors for stainless steel.

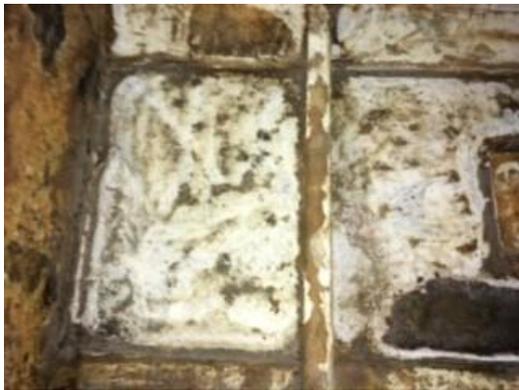
In the right of this picture you can see a black blotch. This was the only piece of rust in the actual keel and I attacked it with the grinder and rattle gun and it was not deep. The corroless paint system will be used in the bilges to stabilize them for the future.

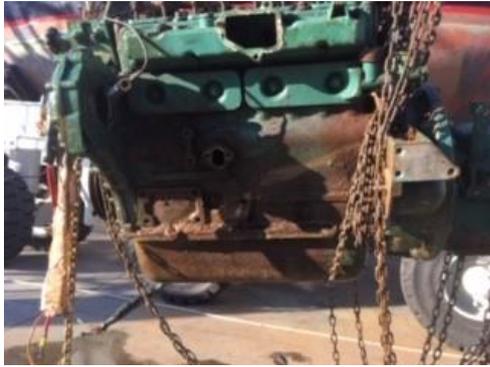
Once it was on the ground, I was extremely happy that we had made a good decision to take it out.. It was in bad shape.

I did a lot of research on engines. New ones, reconditioned ones and eventually we decided that the best thing to do was to rebuild the old engine. Because there was nothing modern between the 80HP range and 150HP

My Engineer's father is a diesel mechanic. He said that he could rebuild the engine in Lithuania and he would love to completely restore the engine. In Lithuania the complete restoration would be much cheaper than the new engine. Plus, I would not need to modify engine base for a new engine. Or go through the process of matriculation with Coastguard.

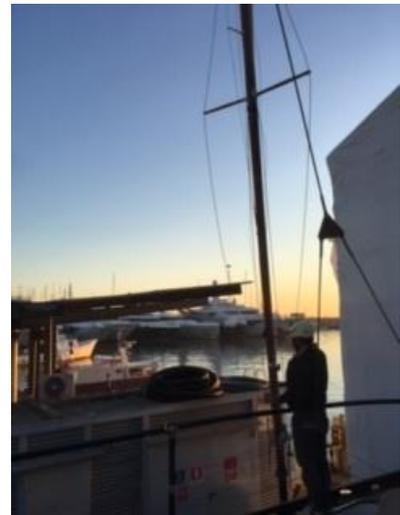
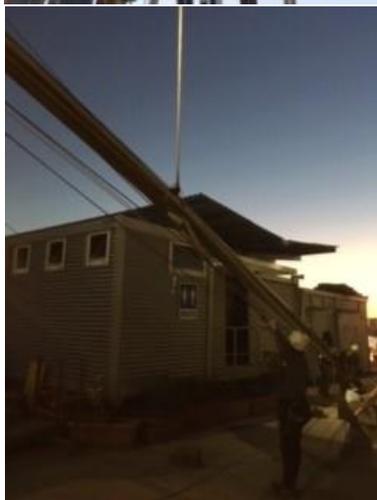
Mizzen took a long time to remove. The timber had swollen and it took a lot of manipulation to remove it.

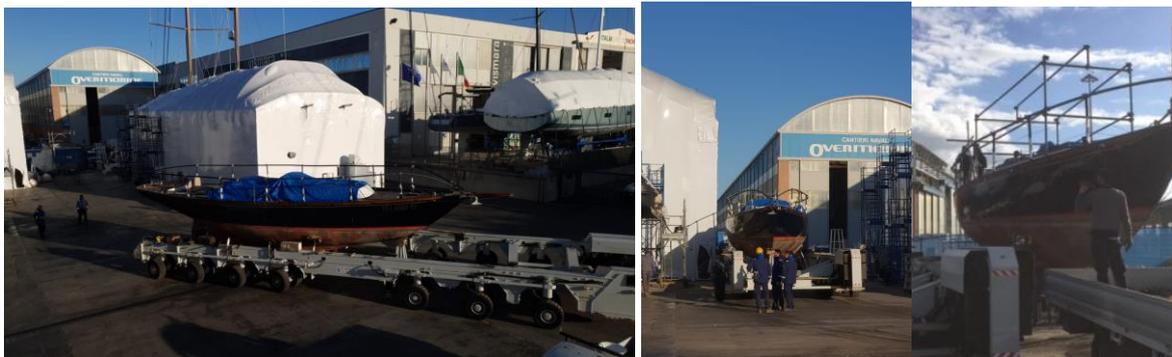
I started works on the steel hull. There was not a lot of corrosion on the outside. There was quit a lot of flaking paint around the rudders which I feathered out. We are using the Corroless primer as metal primer on all areas.

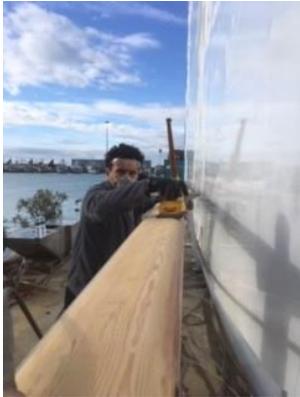
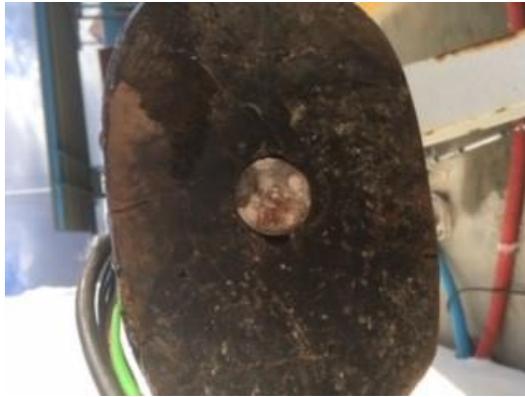
Beautiful bare Oregon pine spars. This was fun. The 500 Lira coin under the mast was checked on the internet. For a day we thought that it was a rare 1957 commemorative coin worth from 30 to 60 000 Euros. Turns out not to be the case so the coin will be returned for good luck.

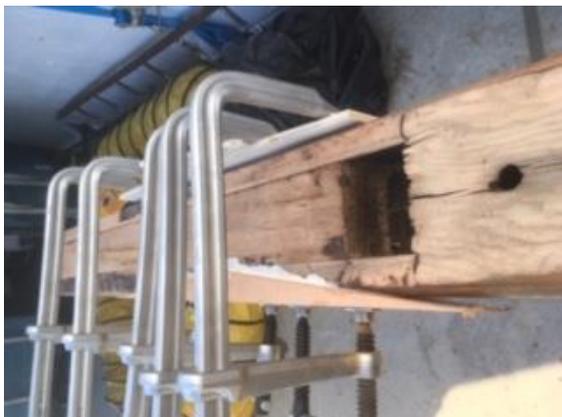
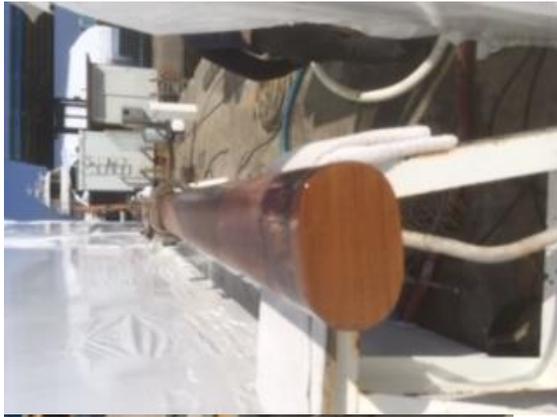
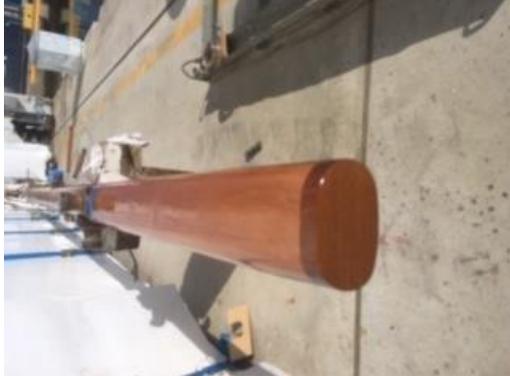
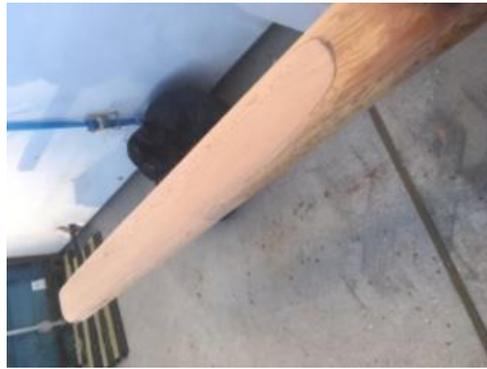
The Mizzen mast had an area of dry rot in it so I had a specialist remove it and scarf in a new section. Both masts were given a teak shoe to prevent moisture rising from underneath.

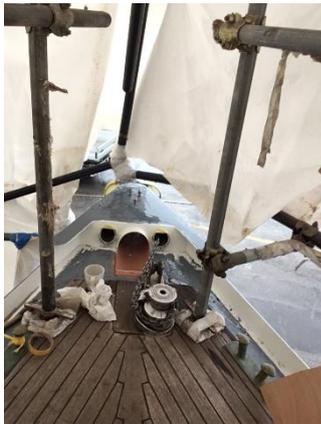
The bowsprit was rotten. It was hollow and full of water through a large split. I decided to make a new one. It took me a week to remove the old one. It was swollen inside the tube and impossible to extract it. The pine wood inside was wet and smelly. Anyway the new bowsprit will be installed correctly. Varnished properly.

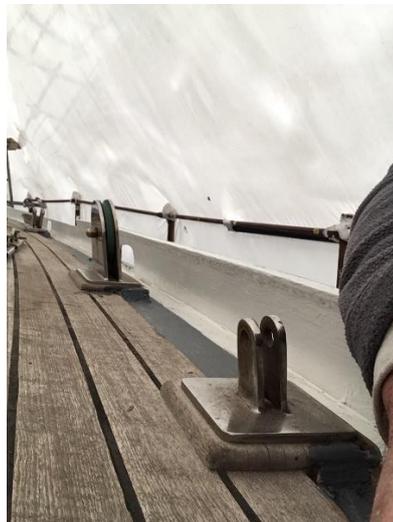
Margine-planks removed. Rusting toerails and scuppers treated with Corroless paint and inside with Awlgrip off white.

With the sandblasting and 3 coats of corroless primer and 2 coats of Awlgrip 545 primer. These toe rails will hopefully never rust again.

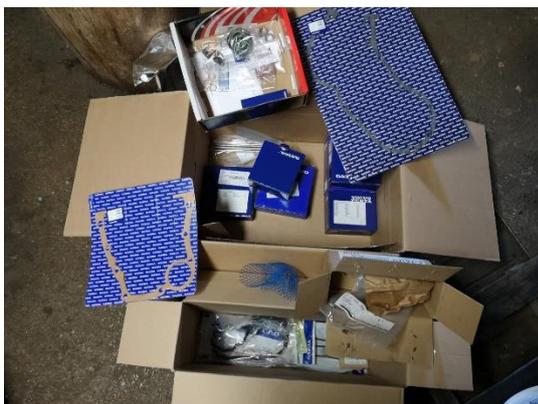
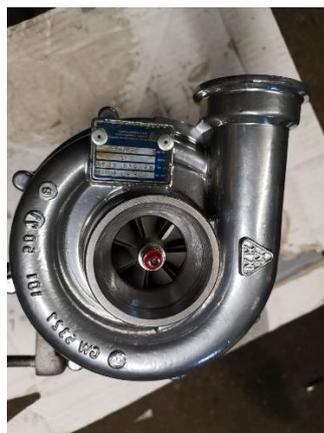
Pictures coming back from mechanic. Engineblock completely refurbished. Sandblasted and powdercoated.

Before picture was pretty scary looking.

All spare parts arrived from Volvo. The turbocharger was sent away for complete overhaul.

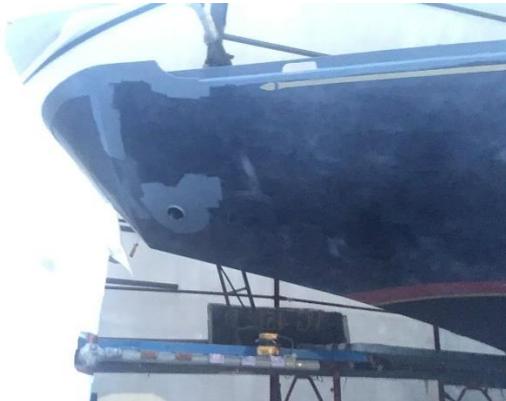
The underwater area was completed. There were areas of rust blisters. Not large ones but small coin size ones. They were treated with rattlegun and grinder. 2 coats of Corroless anti rust primer applied followed by international epoxy filler. The whole hull was sanded and re-faired with this filler. Then the whole boat was primed with an international bridging primer coat 2 coats. 3 coats of Hempel black antifoul applied and then new anodes.

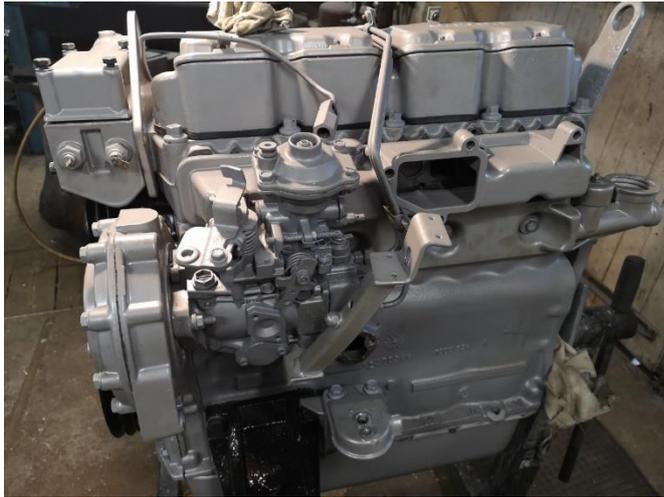
Pictures of the almost complete engine were exciting. I went to see the local Volvo dealer and organised for him to come down and look at the logistics of reinstalling the engine. I have ordered new Morse cables as well as a new gear shift lever.

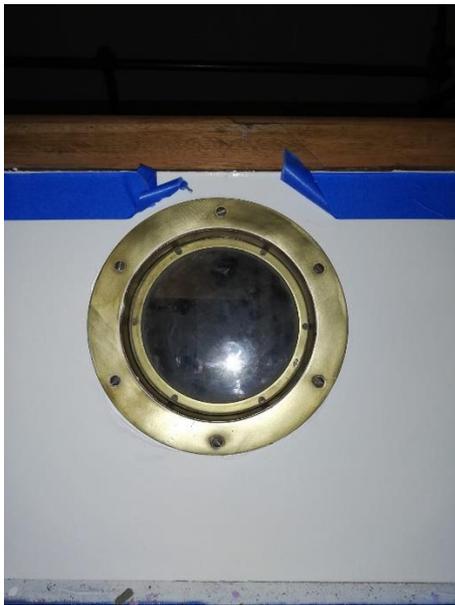
All the bronze portholes were removed for resealing because they were leaking. A couple of the bronze rings were cracked and so were re braised and all polished.

I reinstated the portholes and there is no possibility now of any water leaks. On this yacht. The cabin top will be completely re-caulked 100%

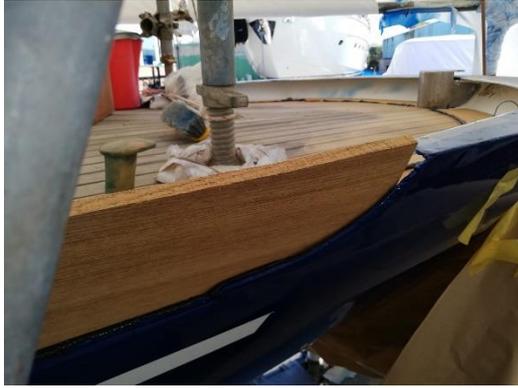
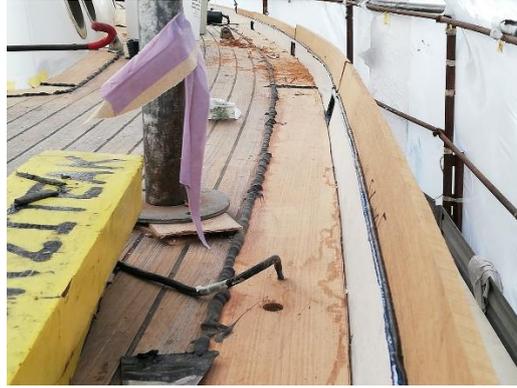
Bilges and tanks done. I started to demolish the old cracked mahogany Margine planks and capping rails. The work was not done well at the last refit. The steel toe rails were rusting because they were sadwiched between wooden laminates on each side so it just encouraged rust. The varnished mahogany margine planks were cracked and looked terrible. So I decided to remove it all including the capping rail and replace with new teak. A varnished capping rail and outboard trim. Interior scuppers would be Awlgrip painted. The margine planks would be bare teak to match the deck. The deck and the plywood underneath were in prefect condition.

Rather than the mahogany steel sandwich that was on the toe rail before. I have decided to go for teak toe rail with a nice size capping rail. The inside scuppers will remain awlgrip paint which will be easy to keep clean. This day was the first piece on the exterior of the hull. Diego plans to epoxy glue a nothe piece on the inside above the steel. Then capping rails on the top.
